# Feedback of an EPDM geomembrane landfill cover 12 years after its installation

**ABSTRACT:** This study concerns the feedback of a synthetic rubber geomembrane EPDM that was installed 12 years ago for the landfill cell cover of Lann Hir. An inspection visit has been organized to assess the condition of the geomembrane and sealing details. Part of the covering soil has been removed to allow visual inspection and take samples of the geomembrane that were subjected to analysis. The publication presents the Lann Hir landfill, the specificities of installing an EPDM geomembrane landfill cover and the test results of the showing that twelve years after its installation, the mechanical characteristics of the EPDM geomembrane and its seams are nearly unchanged.

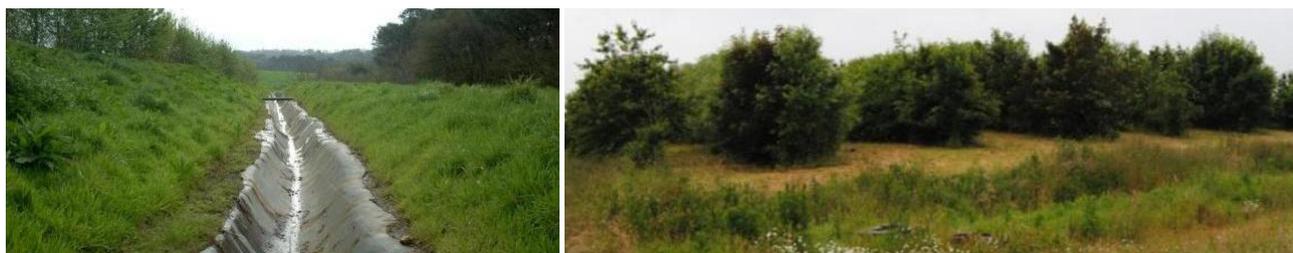
Figure 2. Peripheral ditch at the foot of the mound lined with EPDM geomembrane and current state of the landfill

The owner would like the location to return to its former forest usage. The specifications considered the compatibility of the waterproofing system with a sample of trees with a suitable root system. An access way was created above the waterproof covering and all the ditches (1500 ml) for this cover are waterproofed with EPDM geomembranes (Figure 2).

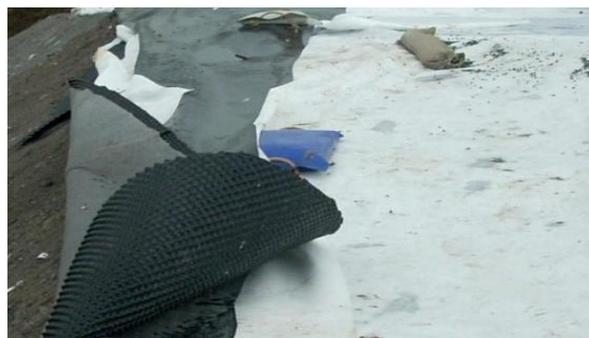
Figure 4. Gas drain geocomposite.

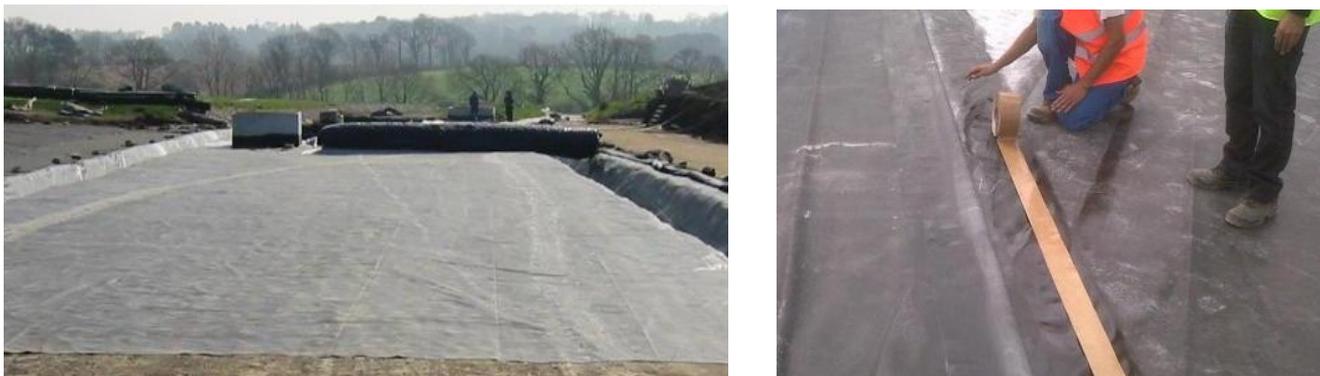
The various panels were assembled on site using self-adhesive tape made from synthetic rubber, and a primer made from solvents and EPDM (Figure 5). The seams were systematically subject to visual inspection, vacuum chamber (individual points) and destructive tests (shearing, peeling). It is also possible to test the taped seams along their length with an air lance system (ASTM D 4437) which consists of directing high pressure air onto the seam.

Figure 5. Installation of the EPDM geomembrane. Creating a seal using self-adhesive tape

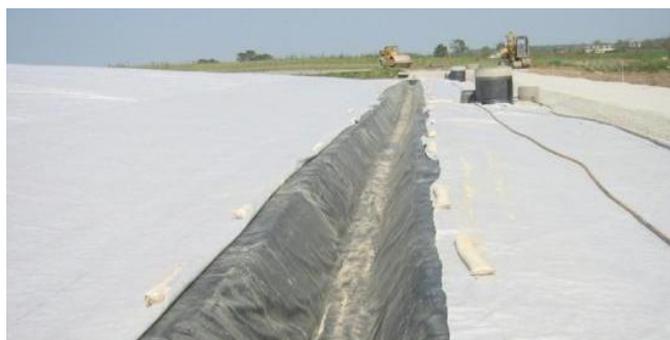
Figure 6. Installation of the peripheral ditch and high protection geotextile

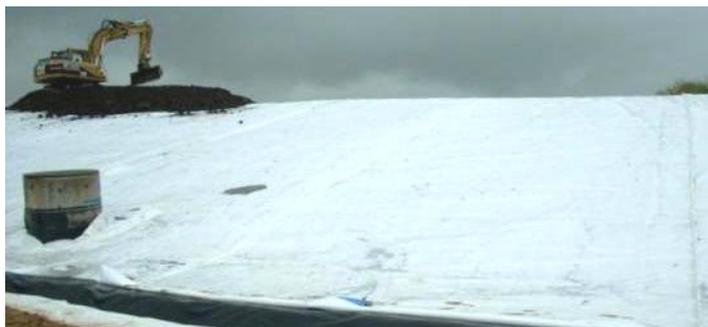
At the Lann Hir site, the lorries were authorised to move around on access ramps 80 cm thick. The levelling of the material was done from the ramp, using a caterpillar track vehicle, authorised to move around on a layer at least 40 cm thick.

Figure 7. Installation of the soil cover

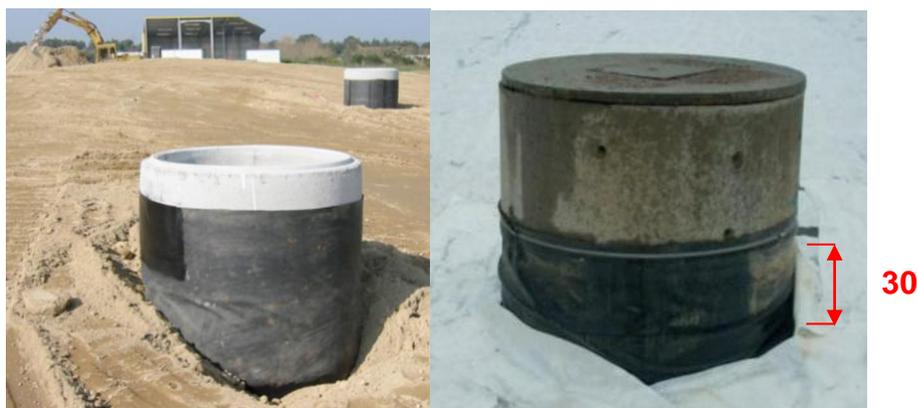
To ensure that this detail does not become strained over time, which may risk compromising the impermeability, the flexibility of the EPDM geomembranes allows for a "safety pleat" to be made outside the soil on the degassing wells (Figure 8 and 9). Then, when the soil around the well settles, the excess geomembrane provided at the well (0.6 m at Lann Hir) means that the geomembrane is not put under strain. The advantage of this feature is that it can be adapted to any diameter and the excess geomembrane can be adjusted to the anticipated differential settling.

Figure 92. Degassing well before and after the addition of a safety pleat

The foot of a biogas collection well had also been cleared in order to inspect the condition of the detail. A well was selected where the safety pleat had been clearly unfolded, a sign of a significant differential settling in that area.

The visual inspection showed that the connection between the well and the geomembrane had not suffered differential settling. Visually, the geomembrane has not been under strain and there is still a significant amount of surplus geomembrane to withstand any possible future settling.

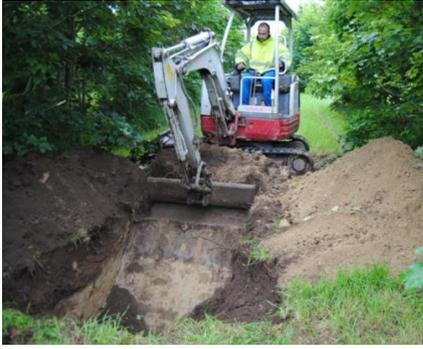
To begin with the soil cover was excavated using a mini digger (Figure 10). The last centimetres were removed using a scoop so as not to damage the impermeable geomembrane system.

Figure 10. Starting the excavation to take the samples

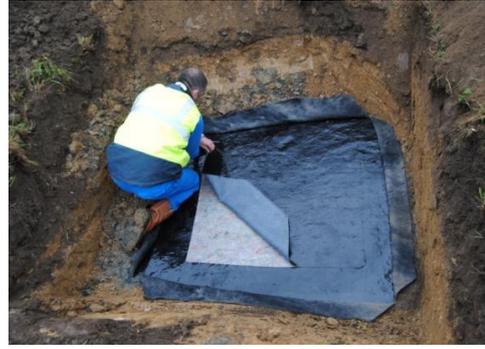
Samples sized at approximately 1.0 m x 1.0 m were cut using scissors (Figure 11).

Figure 11. Taking samples of the EPDM geomembrane

After taking the samples, the sample area was repaired by an Asqual certified welder. The existing geomembrane had been carefully cleaned using a naphtha based solvent. A new piece of EPDM has been cut to the dimensions and fitted to the geomembrane on site using a self-adhesive tape.

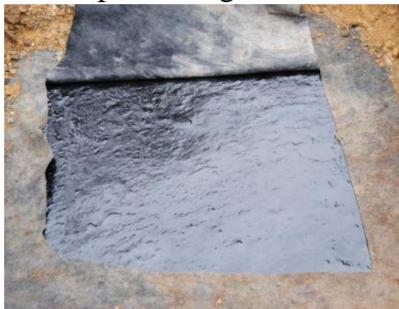
The pieces of geomembrane taken as samples did not present any visible fault or perforation. The protective geotextiles (above and below) were also in very good condition. It should be noted that the upper geotextile showed substantial coloration (the origin of which has not been determined) while the lower geotextile had retained its original color (Figure 12). This observation shows the role of the geomembrane in preventing infiltration.

Figure 12. EPDM geomembrane and color difference between the upper and lower geotextile

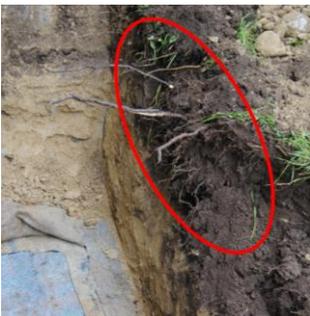
We were also able to observe that the thicknesses of the soil cover had been respected (85 cm). The excavation showed that roots of the vegetation planted on the cover remained in the top 40 centimeters of the topsoil.

Figure 13. Location of the root zone

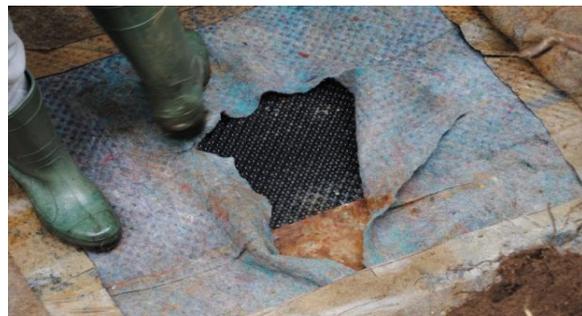
The gas drain geocomposite located under the geomembrane and lower protective geotextile was still in a very good condition (Figure 14). No clogging was observed in the drain area.

Figure 14. Protective geotextile and gas drainage placed under the geomembrane
