Firestone GeoGard™ EPDM

Expectation of behaviour in the event of an earthquake

Balsa de los Pozos - Lorca - Spain

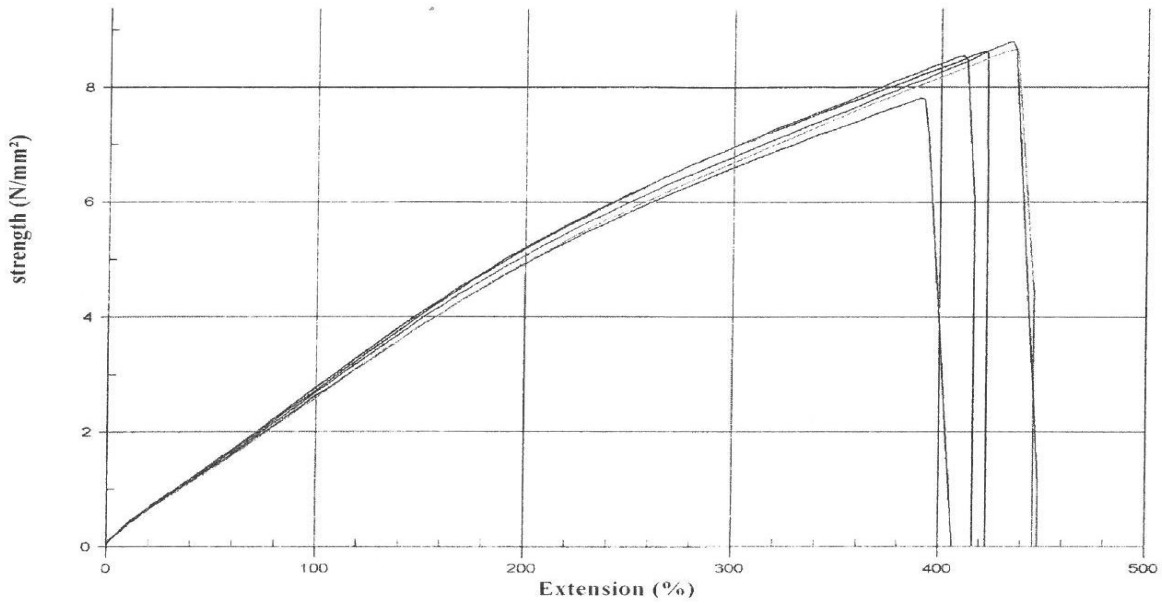
We believe that the reasons why this event didn't result in a catastrophic failure of the GeoGard are directly linked to its elasticity and flexibility. The GeoGard is a purely elastic membrane with no yield point (see below a typical stress strain curve of Firestone GeoGard EPDM). Now, it can be stretched up to 300% without being damaged. Another geomembrane with less elongation but higher tensile strength (like a reinforced EPDM for example) would probably have not behaved as well. The reinforcement reduces the elongation properties of the geomembrane and therefore its deformability and adaptability to external stresses.

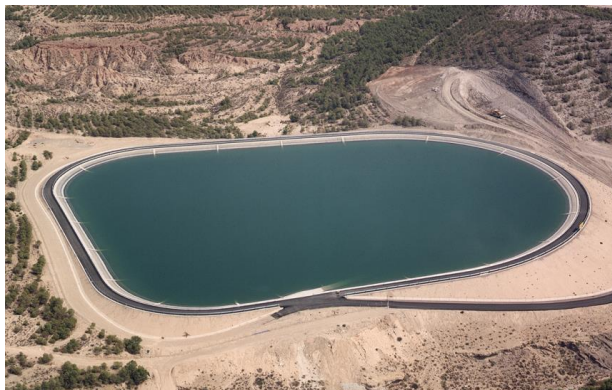
Aerial picture of the pond in 1998

Location:	Lorca Spain
Owner:	Mancomunidad de canales del Taibilla
Name:	Balsa de los Pozos
Geomembrane:	Firestone GeoGard™ EPDM
Installation year:	1998
Volume:	224.000 m³
Lined surface:	44.000 m²
Depth:	9,5 m

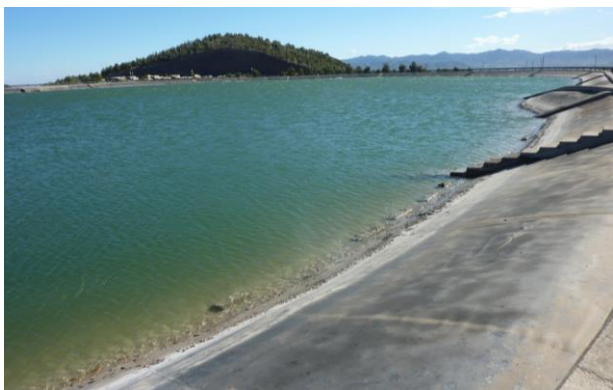
Picture of the pond in 2013

After the earthquake, the maintenance team monitored the reservoir 24h a day for two weeks and discovered that even though the entire pond had been displaced by several tens of centimeters, no leaks or damage to the geomembrane were observed. No leaking water came through the water drainage system located under the liner.

The same membrane is still functioning in perfect working order today, 16 years after its installation.

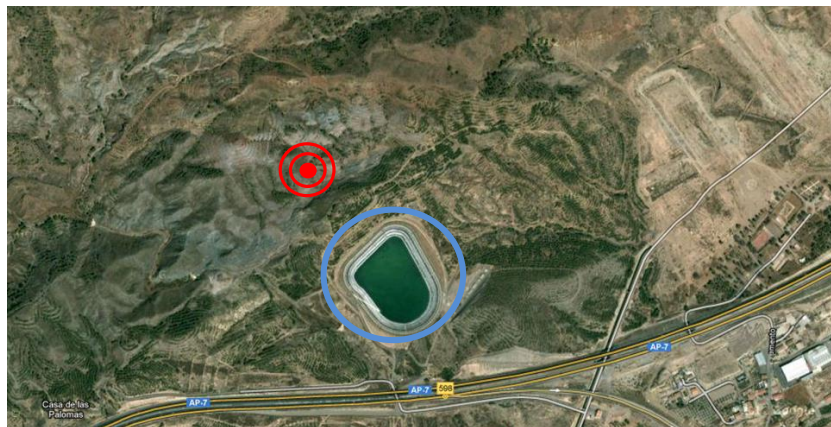
The aerial picture and drawing below show the proximity between the epicenter of the main quake and the water pond.

Epicenter of the earthquake

Location of the pond

In 2011 the city of Lorca was severely damaged by a 5.1 earthquake (and several aftershocks). It was particularly destructive as its epicenter was only 1 km deep. The total strength of this event was similar to the explosion of 200 tons of TNT. As shown in the satellite picture below, the epicenter was located very close to the water reservoir (a few hundred meters).

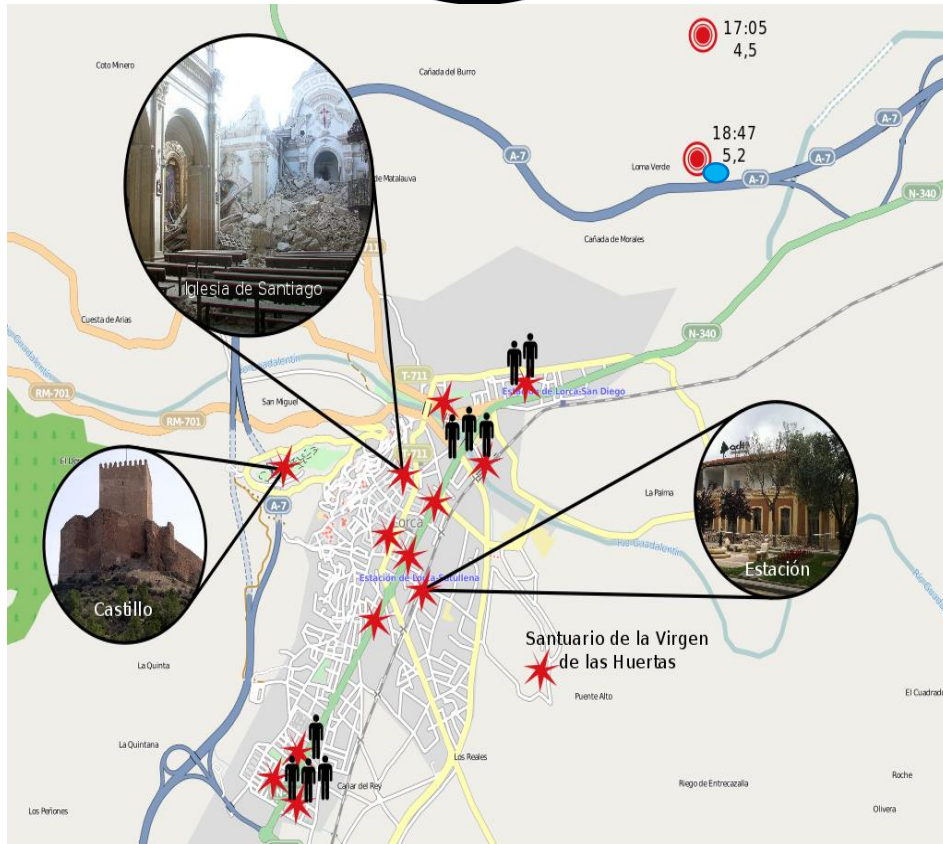
Epicenter Damaged buildings Human victims Location of the pond
