Klondyke Irrigation Canal • South Canterbury - New Zealand

Lining in Action™

An effective lining solution to conserve water

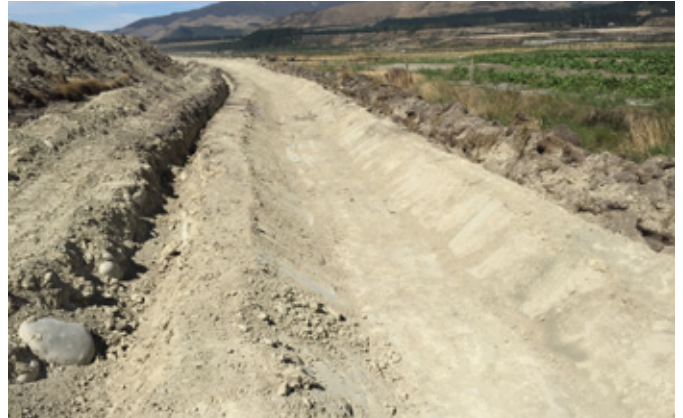
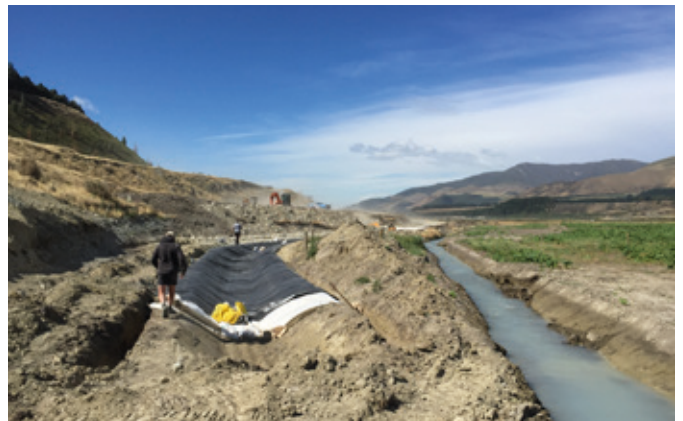
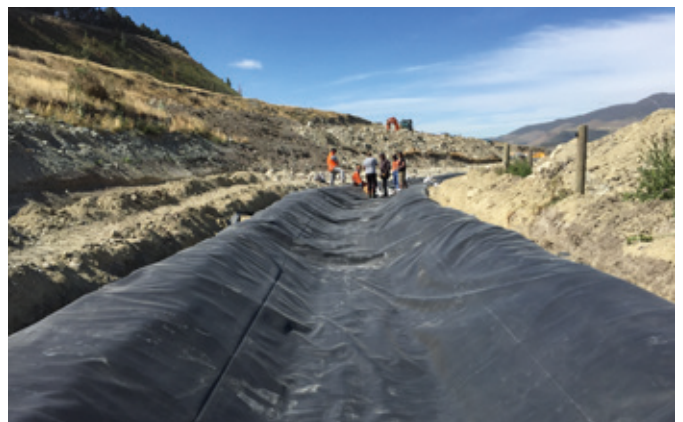
Due to the remoteness of the location and the narrowness of the ditch, five laborers and one technician worked alongside the contractor to ensure the job was completed in 12 days. There were large rounded boulders in the new ditch which could not be completely removed. Thanks to the GeoGard membrane ability to conform over these subgrade protrusions and its superior puncture resistance, this was not an issue for the contractor. A 250 g/m² non-woven Bidim A29 geotextile underliner fabric was used to further improve the puncture resistance of the EPDM geomembrane.

The irrigation ditch was relatively small, approximately 0.5 m deep x 2.5 m wide (at the top). The flexibility of the GeoGard membrane adapted effortlessly into the angle changes from floor to batter to anchor trench, thereby providing the recommended intimate contact with the support surface, which would have been very challenging if rigid membranes had been used.
